Found on Deck

By AS2 Thomas Bach, USS Kearsarge (LHD-3)

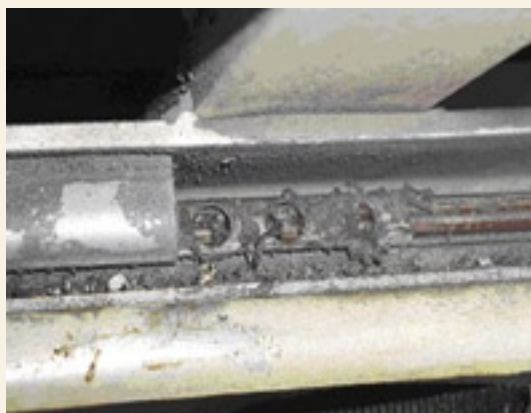
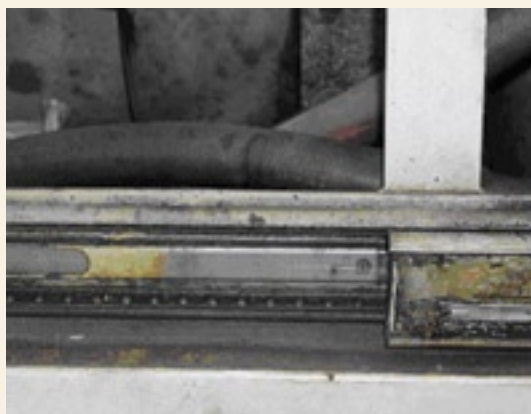
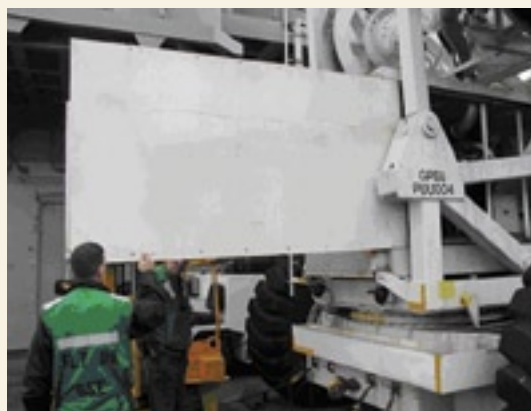
A close inspection of the crash crane by numerous support-equipment technicians revealed the source of the FOD. The doors on the engine-hood assembly of the crash crane use ball bearings to assist in opening and closing. The doors had been removed, and eight ball bearings were missing.

Further investigation produced an additional five bearings that were out of the track, as well. The door-slide track was damaged and would not hold the bearings in place. Review of current Periodic Maintenance Instructions did not reveal any requirement to open, close, lubricate or inspect the chassis doors. A recommendation was submitted to the CFA to add an MRC to include these steps at a specified interval.
